INVESTIGATION OF THE FORMATION AND BEHAVIOR
OF CLOGGING MATERIAL IN EARTH AND
SPACE STORABLE PROPELLANTS

FINAL REPORT 08113-6025-R000

NOVEMBER 1969

THE JET PROPULSION LABORATORY
PASADENA, CALIFORNIA 91103
UNDER NATIONAL AERONAUTICS AND SPACE
ADMINISTRATION CONTRACT NAS 7-549

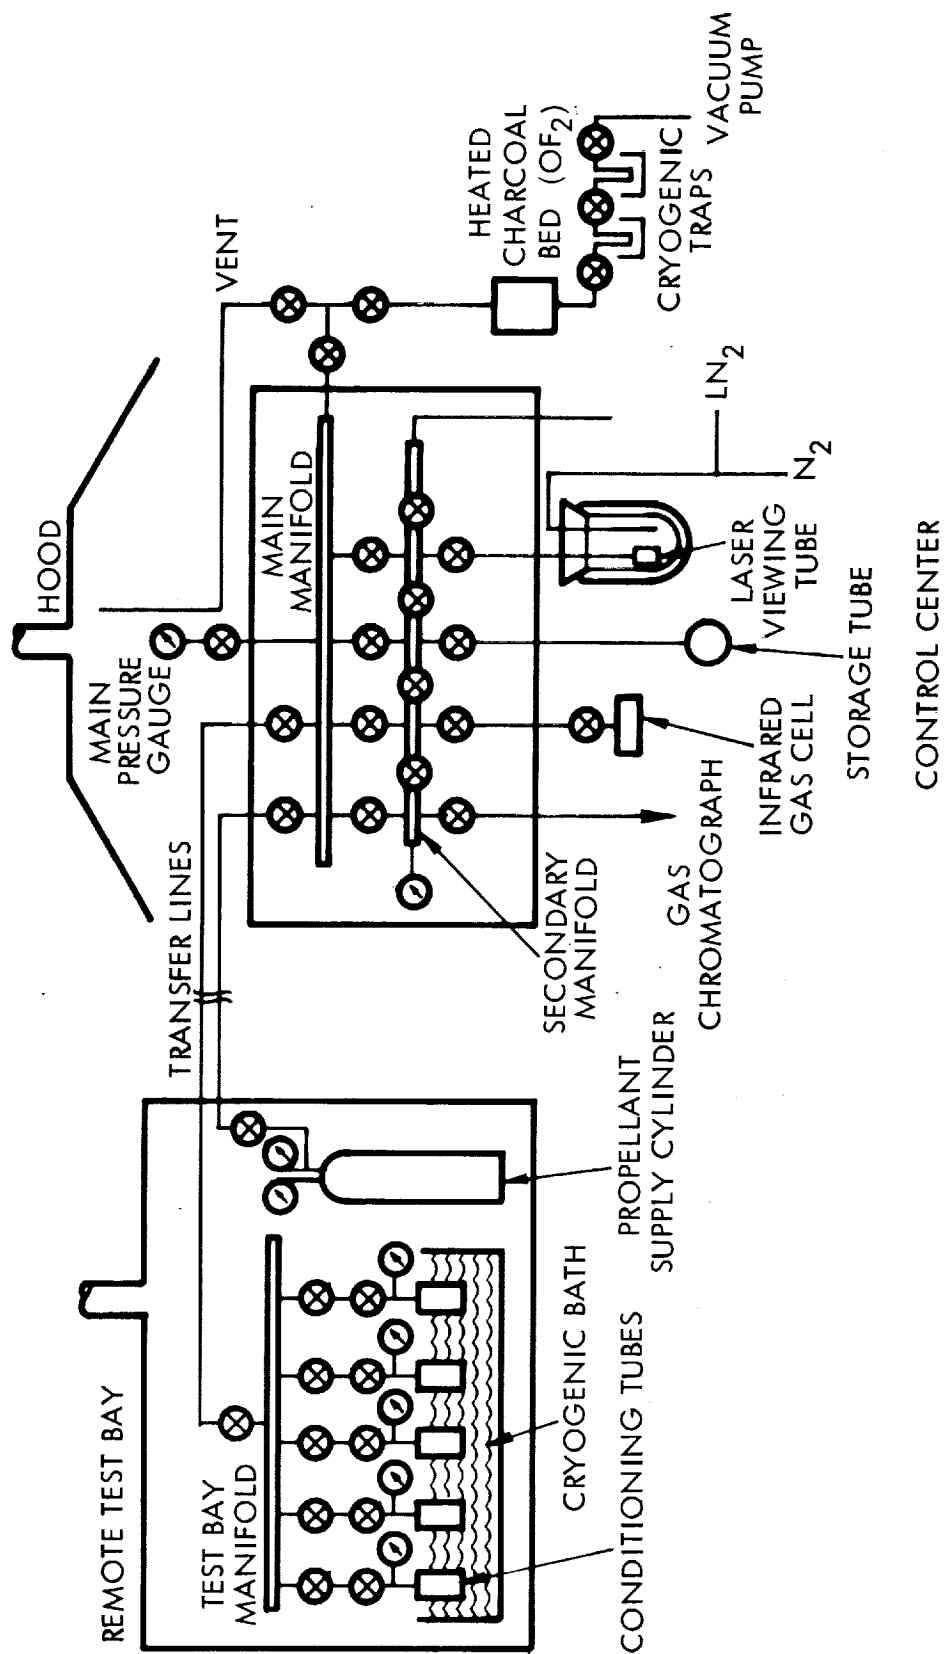
Figure 2-1. Schematic Diagram of Transfer System and Storage Facility for OF_2 Corrosion Study

Because of the extreme toxicity of propellants and the capacity of OF_2 to ignite and burn fuels and metals, low pressure and low temperature vacuum transfer methods were used. The test facility for OF_2 , constructed of 300 series stainless steel lines, valves and fittings, is shown schematically in Figure 2-1. A similar all-glass transfer system, not shown, was used for handling B_2H_6 .

1. Cleaned specimens were placed in the storage containers and sealed to the test bay manifold (Figure 2-1) with pipe threads lubricated and sealed with Teflon tape.
2. The apparatus was pressure tested and vacuum tested until leaks were eliminated.
3. Dopants and propellants were added in proper sequence depending on volatility, so that the reactants were not brought together at a temperature higher than the storage temperature of -78°C .
4. Propellant was added to cover approximately one-half of the test coupon. The propellant was allowed to reach equilibrium vapor pressure at -78°C .
5. The propellants and test coupons were stored for 45 days prior to removal of the propellant for analyses and characterization of the liquid state.
6. Non-volatile residues and test specimens remaining in the storage containers were submitted for metallographic analyses.

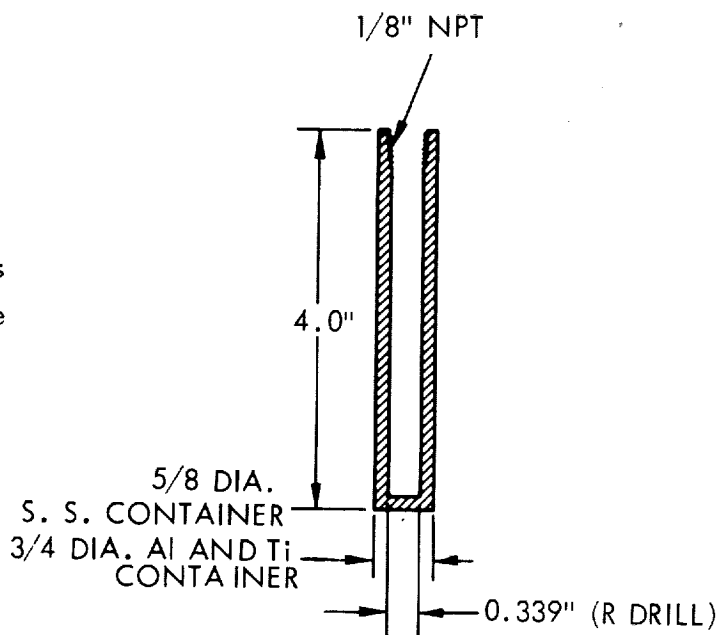
Figure 2-2. Configuration of Storage Container

The storage containers were machined from metal stock to approximately the dimensions of a Hoke Inc., Cylinder 2HS10. The capacity of the cylinder was 6ml. The containers were double valved and capped with AN fittings. Dimensions of the storage container are shown in Figure 2-2. The storage containers were prepared and cleaned to the schedule reported in Table 2-1.

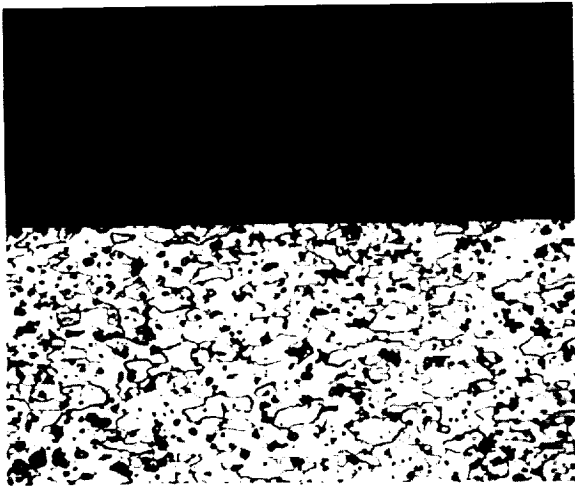
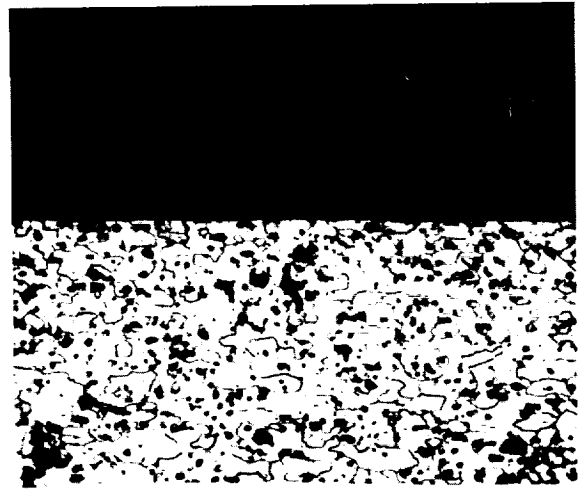
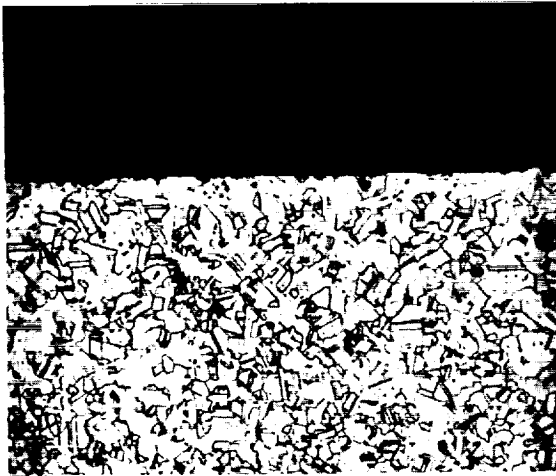
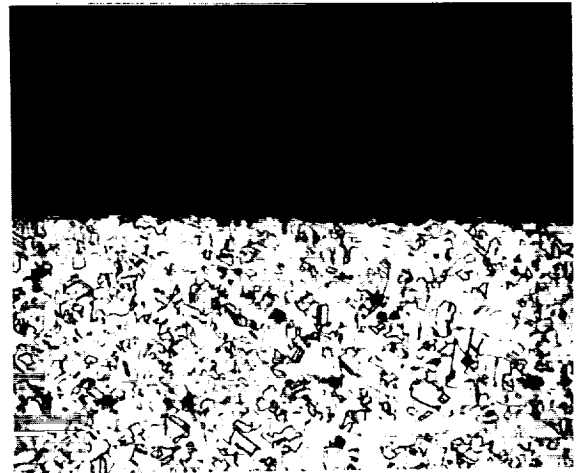
Figure 2-3. Comparison of the Longitudinal and Transverse Cross-Section of the Control Specimens Used in the Corrosion Tests

a. 6061-T6 Longitudinal View
(Original Magnification 200X)

b. 6061-T6 Transverse View
(Original Magnification 200X)

c. 347 SS Longitudinal View
(Original Magnification 200X)

d. 347 SS Transverse View
(Original Magnification 200X)

e. Titanium Alloy Longitudinal View
(Original Magnification 200X)

f. Titanium Alloy Transverse View
(Original Magnification 200X)

The corrosion specimens were prepared and cleaned to the schedule reported in Table 2-1. The results of metallographic examination of representative samples in the "as received" condition were used to establish a baseline comparison with the specimens after storage.

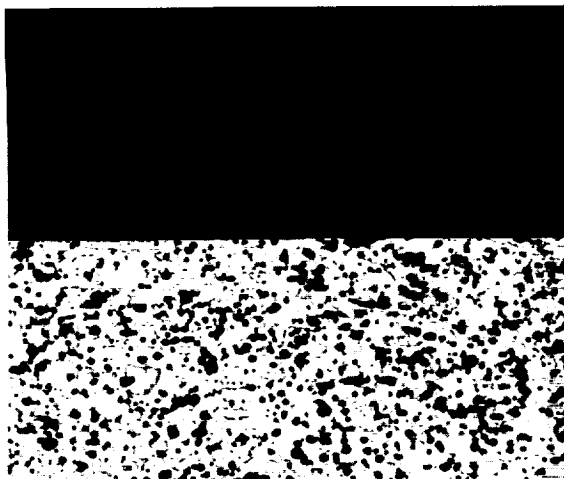
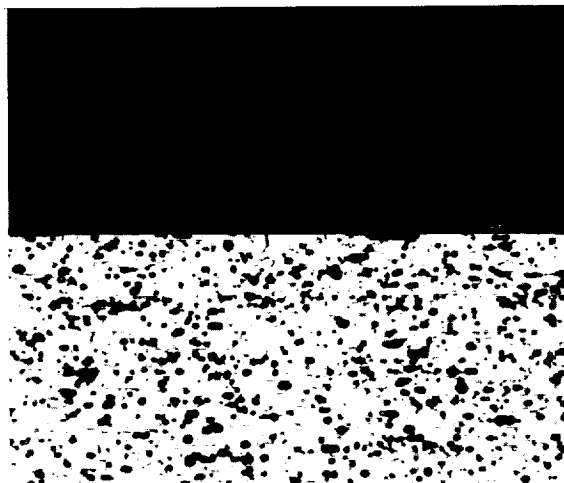
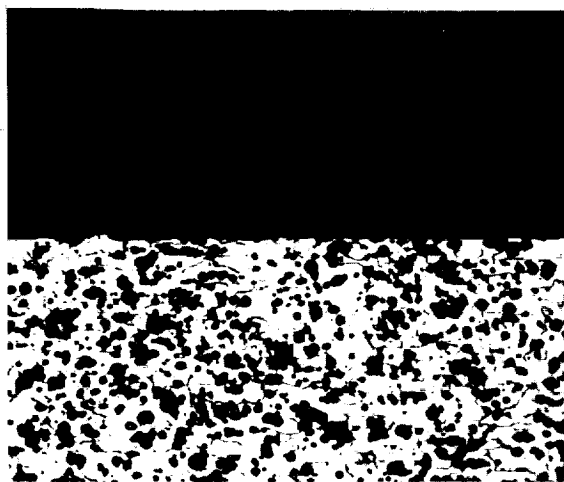
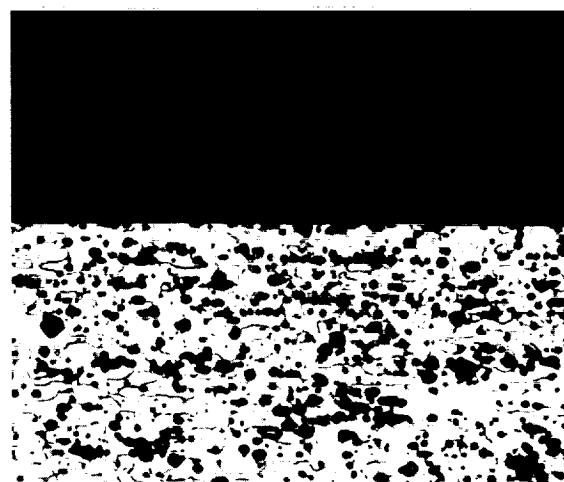
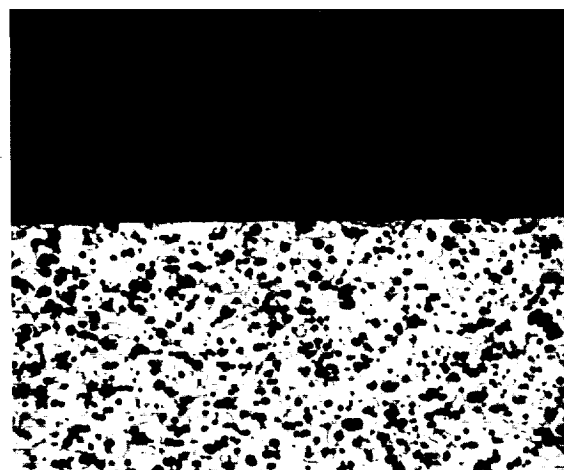
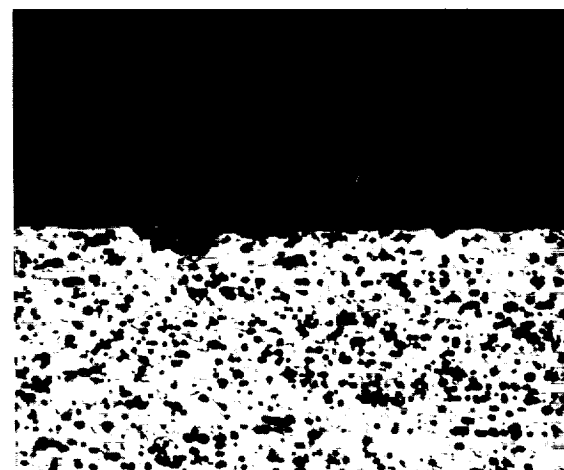
Figure 2-4. Comparison of the Corrosivity of Diborane and Oxygen Difluoride on 6061-T6 Aluminum Specimen

a. B_2H_6 Longitudinal Cross-Section
(Original Magnification 200X)

b. B_2H_6 Transverse Cross-Section
(Original Magnification 200X)

c. OF_2/Al Bomb Longitudinal Cross-Section
(Original Magnification 200X)

d. OF_2/Al Bomb Transverse Cross-Section
(Original Magnification 200X)

e. OF_2/SS Bomb Longitudinal Cross-Section
(Original Magnification 200X)

f. OF_2/SS Bomb Transverse Cross-Section
(Original Magnification 200X)

The aluminum specimen exposed to the doped OF_2 and stored in the aluminum bomb exhibited a slightly brighter surface and some pitting, which appeared to be more uniform over the exposed surface. The larger pits measured about 0.0003-inch diameter x 0.0003-inch deep and represented about 10 percent of the total ($220/\text{in}^2$) pits. The aluminum specimen stored in the stainless steel bomb, however, was more severely pitted, particularly in the transverse section, and seemed to be concentrated in the rolling marks on the specimen. The total pitting approximated $430 \text{ pits}/\text{in}^2$ and about 40 percent of these were the larger pits measuring at least 0.0025-inch diameter x 0.0006-inch deep. It is not known if the change in the corrosion behavior and surface appearance of the two aluminum samples is due to galvanic coupling with the stainless steel bomb, or if there was an interaction between the corrosion products of the aluminum specimen and the stainless bomb.

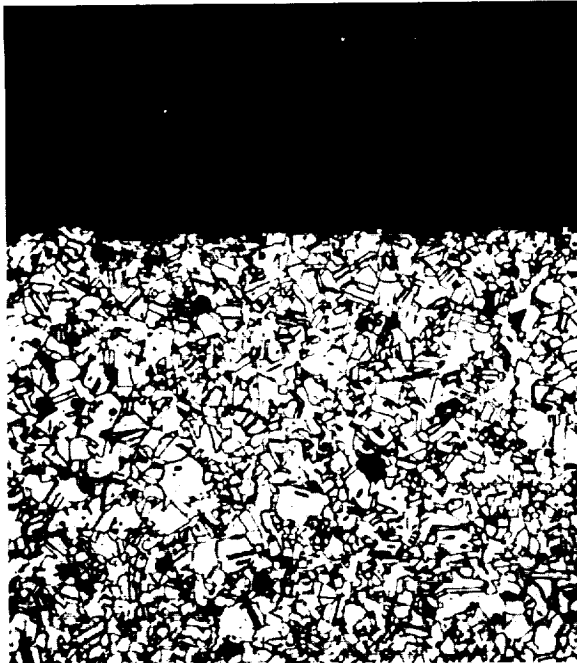
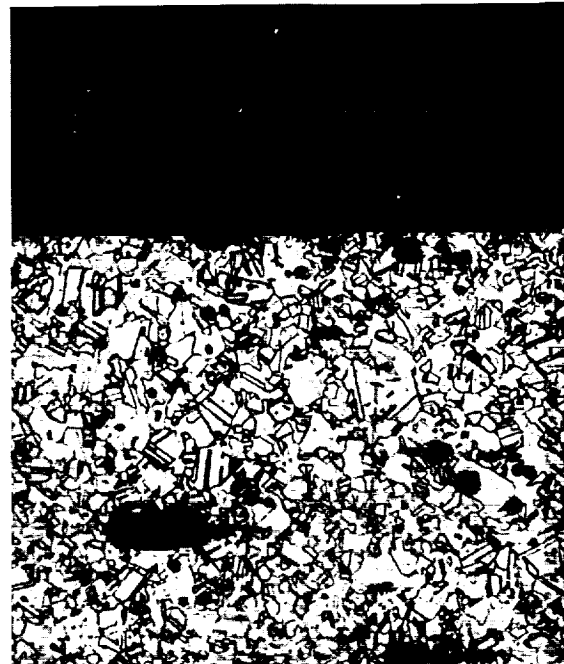
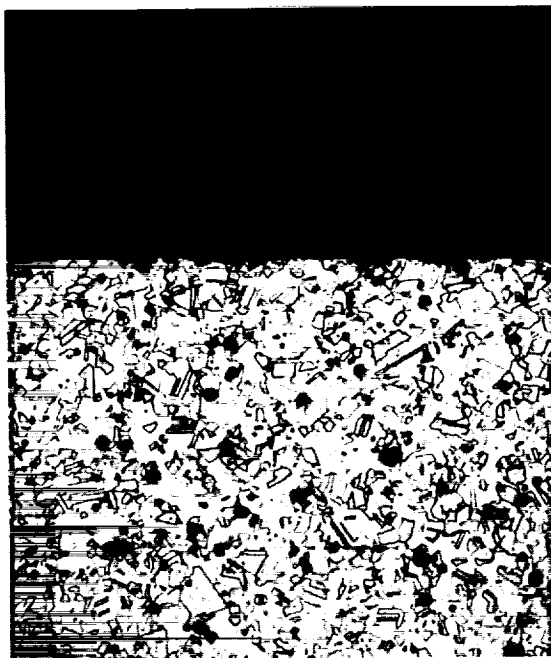
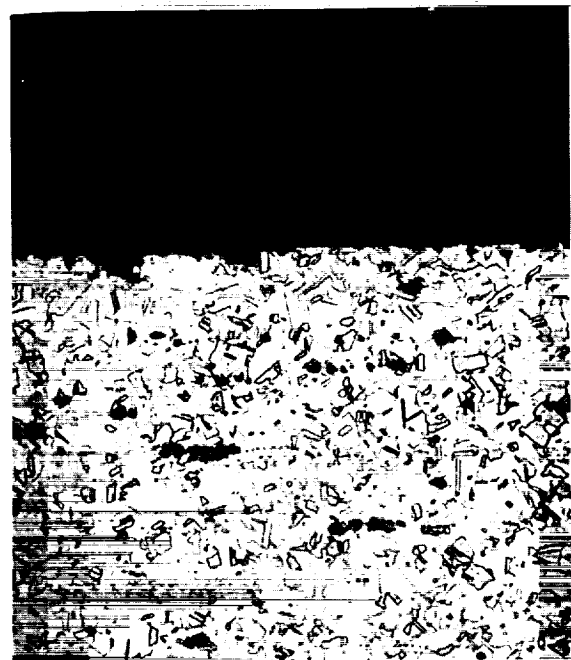
Figure 2-5. Comparison of the Corrosivity of Diborane and Oxygen Difluoride on 347 Stainless Steel Specimen

a. B_2H_6 Longitudinal Cross-Section
(Original Magnification 200X)

b. B_2H_6 Transverse Cross-Section
(Original Magnification 200X)

c. OF_2 Longitudinal Cross-Section
(Original Magnification 200X)

d. OF_2 Transverse Cross-Section
(Original Magnification 200X)

The stainless steel was relatively unaffected by the diborane, with only very minor pitting evident. The specimen exposed to oxygen difluoride showed slightly more pitting, although still relatively minor, and the surface was darkened slightly. Of the three alloys tested, the 347 stainless steel showed the least attack to either propellant.

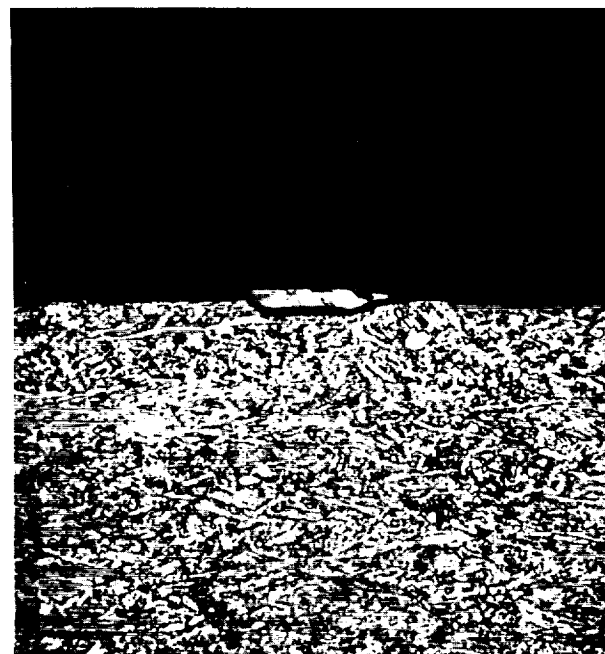
Figure 2-6. Comparison of the Corrosivity of Diborane and Oxygen Difluoride on Titanium 6Al-4V Alloy Specimen

a. B_2H_6 Longitudinal Cross-Section
(Original Magnification 200X)

b. B_2H_6 Transverse Cross-Section
(Original Magnification 200X)

c. OF_2 Longitudinal Cross-Section
(Original Magnification 200X)

d. OF_2 Transverse Cross-Section
(Original Magnification 200X)

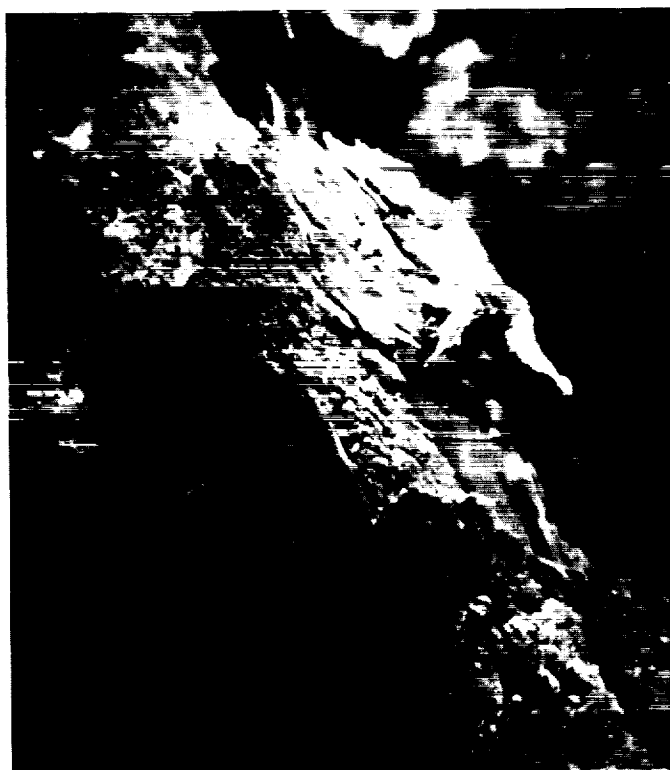
Figure 2-8. Scanning Electron Photomicrographs of 304
Stainless Steel Oxide Powder - Continued

g. Powder (-325 mesh) in Contact with B_2H_6 - $-78^{\circ}C$ for 30 days (Original Magnification: 1000X)

h. Powder (-325 mesh) in Contact with B_2H_6 - $-20^{\circ}C$ for 30 days (Original Magnification: 3000X)

i. Powder (-325 mesh) in Contact with B_2H_6 - $-20^\circ C$ for 30 days
(Original Magnification: 3000X)

j. Powder (-325 mesh) in Contact with B_2H_6 - $-20^\circ C$ for 30 days
(Original Magnification: 100X)

k. Powder (-325 mesh) in Contact With B_2H_6 - $-20^\circ C$ for 30 days. Fused Chip
(Original Magnification: 100X)

l. Powder (-325 mesh) in Contact With B_2H_6 - $-20^\circ C$ for 30 days. Fused Chip
(Original Magnification: 1000X)

Figures 2-8k and 2-8l show the appearance of the fused portion of the sample stored at -20°C for 30 days. Figure 2-9 is a photomicrograph of the entire fused chip, with the metallic inclusions clearly visible on the surface. The scanning electron photomicrographs (Figures 2-8k and 2-8l) show that the oxide particles have fused together into a laminar or foliated structure with no clearly discernable grain boundaries.

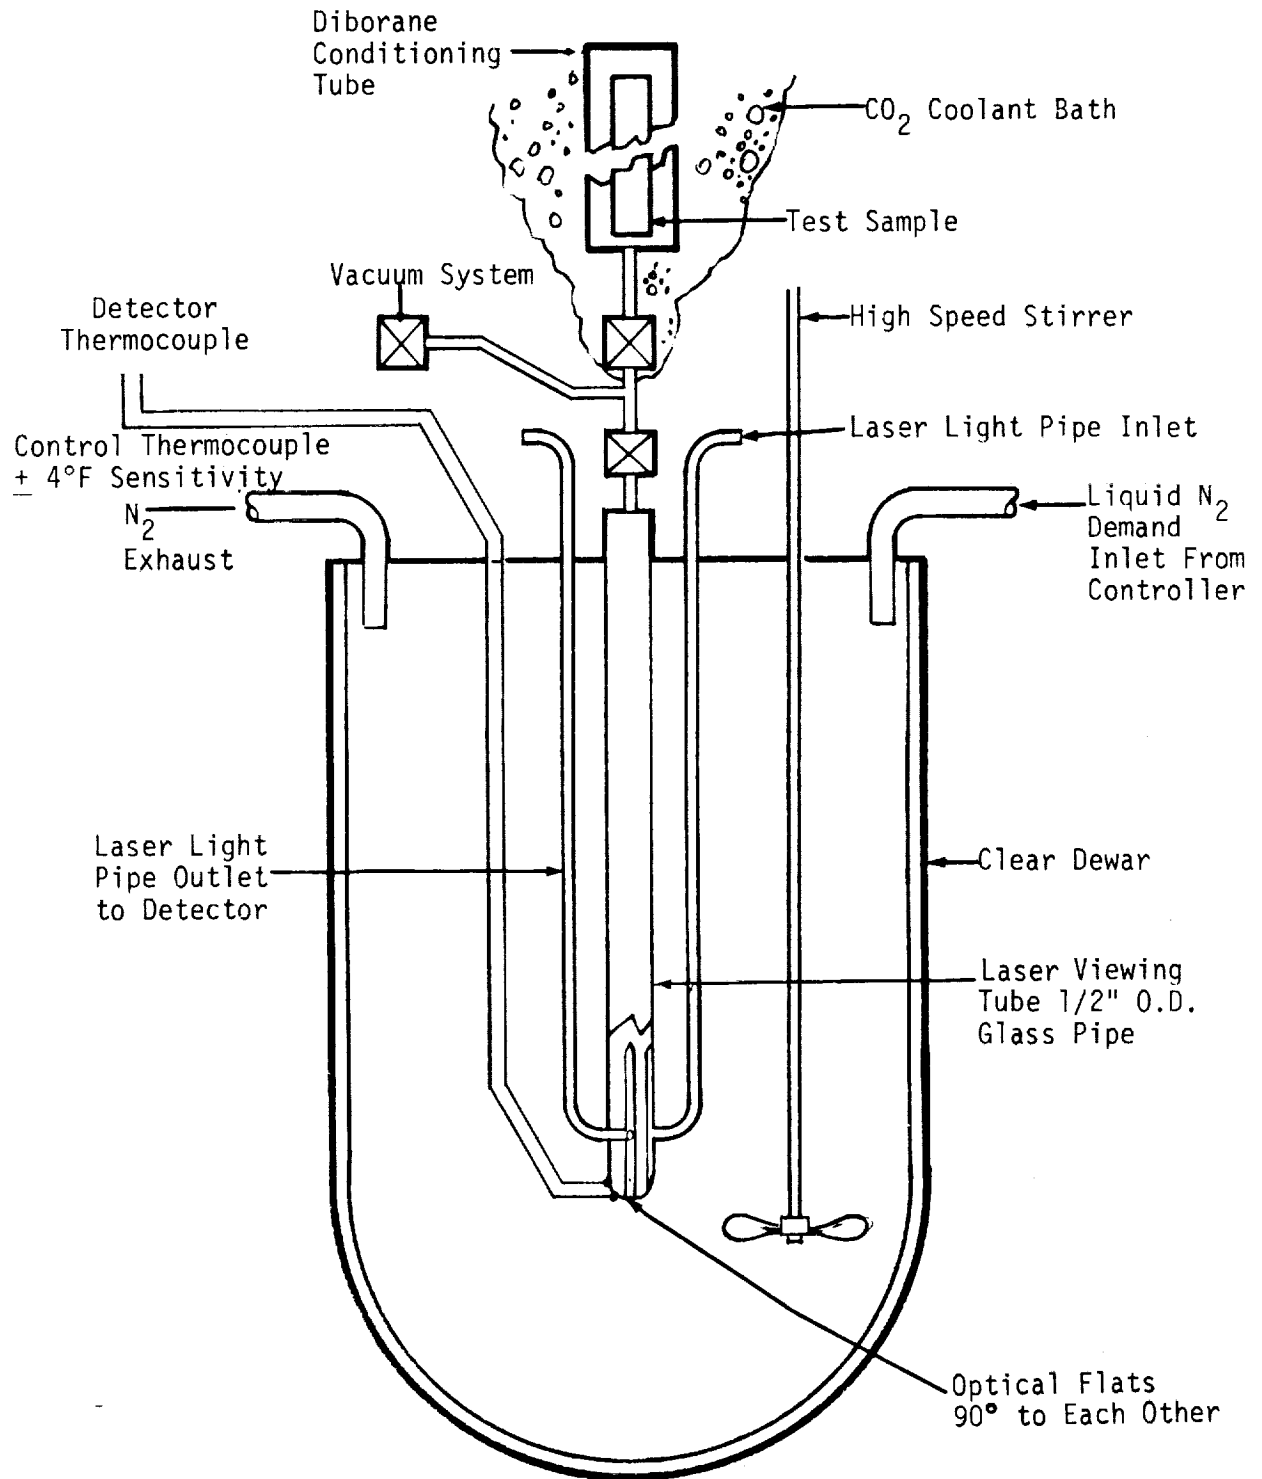
Figure 3-1. Laser Viewing Assembly

Cryostat temperature was controlled by liquid nitrogen coolant delivered on demand using thermocouple sensors. A high speed stirrer circulated the nitrogen coolant continuously to assure temperature control.

The assembly was constructed to permit either vacuum transfer of the propellant sample to the viewing tube, or direct loading by pouring the sample into the top as shown in Figure 3-1. The latter method was considered to be the best method for obtaining a true sample of the propellant and more likely to contain the non-volatile impurities. However, for glass apparatus, it was not safe to transfer the conditioning tube with the liquid OF_2 at -78°C because of the high vapor pressure, 415 psig, at this

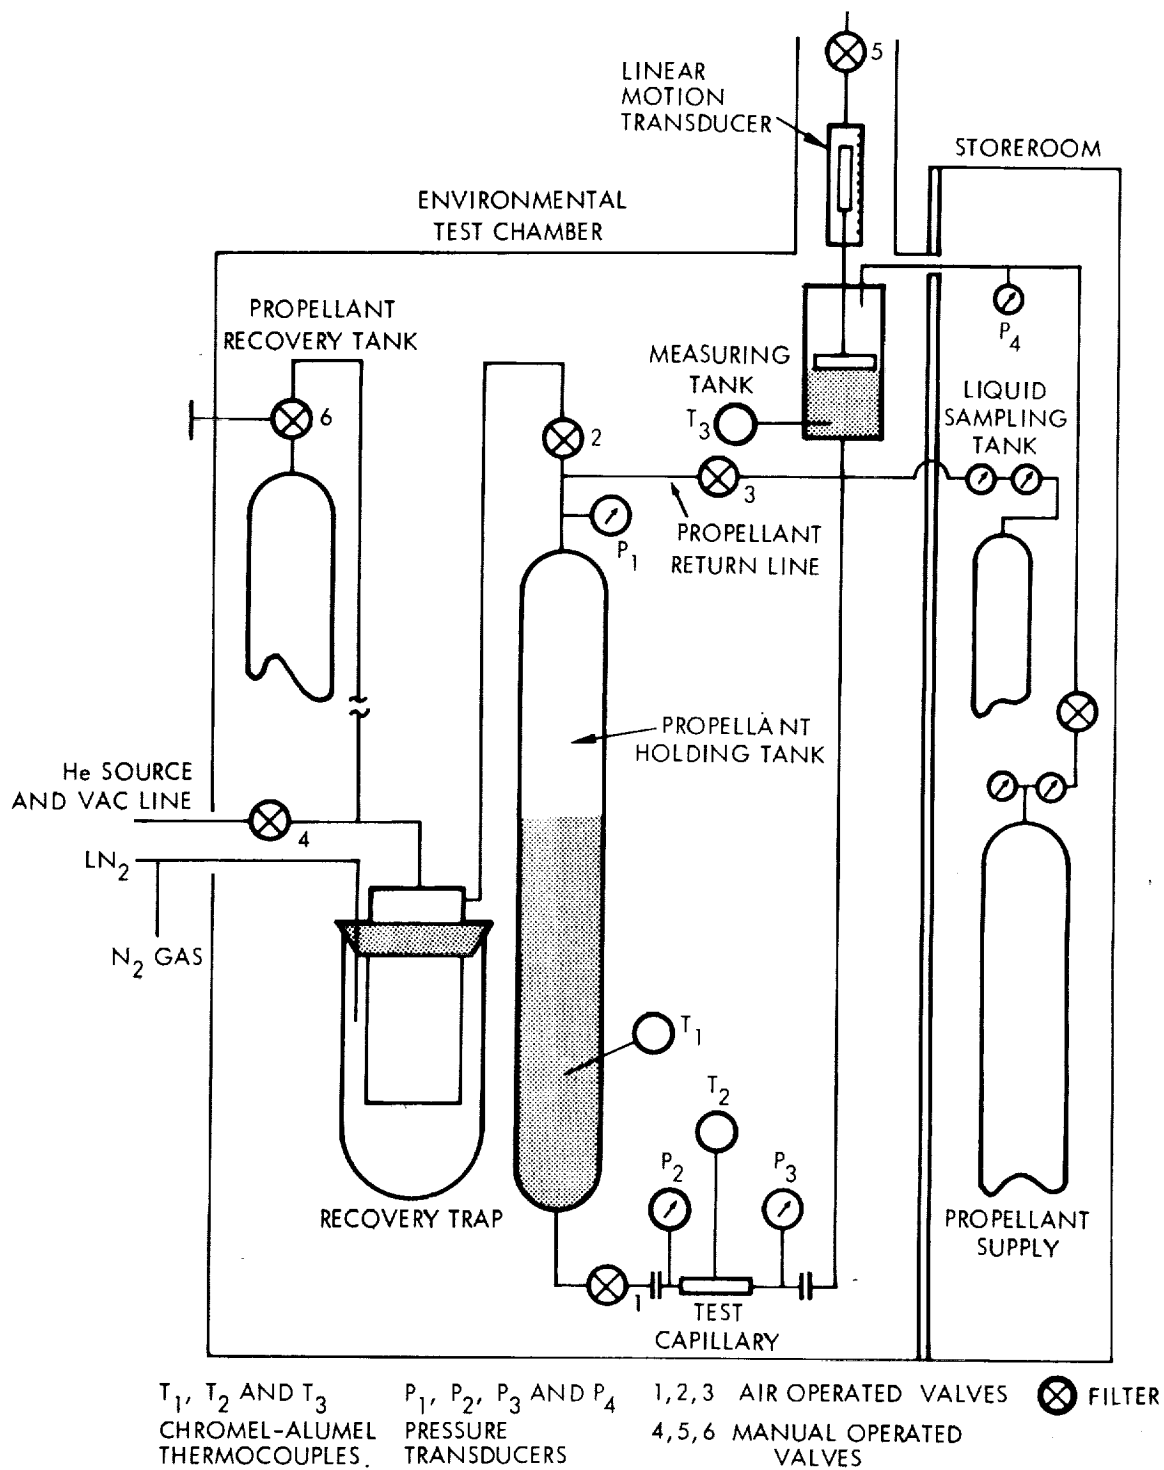
Figure 4-1. Schematic Diagram of Test Facility for $\text{OF}_2/\text{B}_2\text{H}_6$ Flow System

The apparatus was constructed to contain and flow as much as one liter or quart of liquid propellant (three pounds of OF_2 or one pound of B_2H_6). A test capillary was chosen which had a 100:1 ratio of length to internal diameter, 0.010-inch I.D. The internal diameter was verified by passing a 0.009-inch diameter wire through the capillary, whereas a 0.010-inch diameter would pass only partially through each end of the tube.

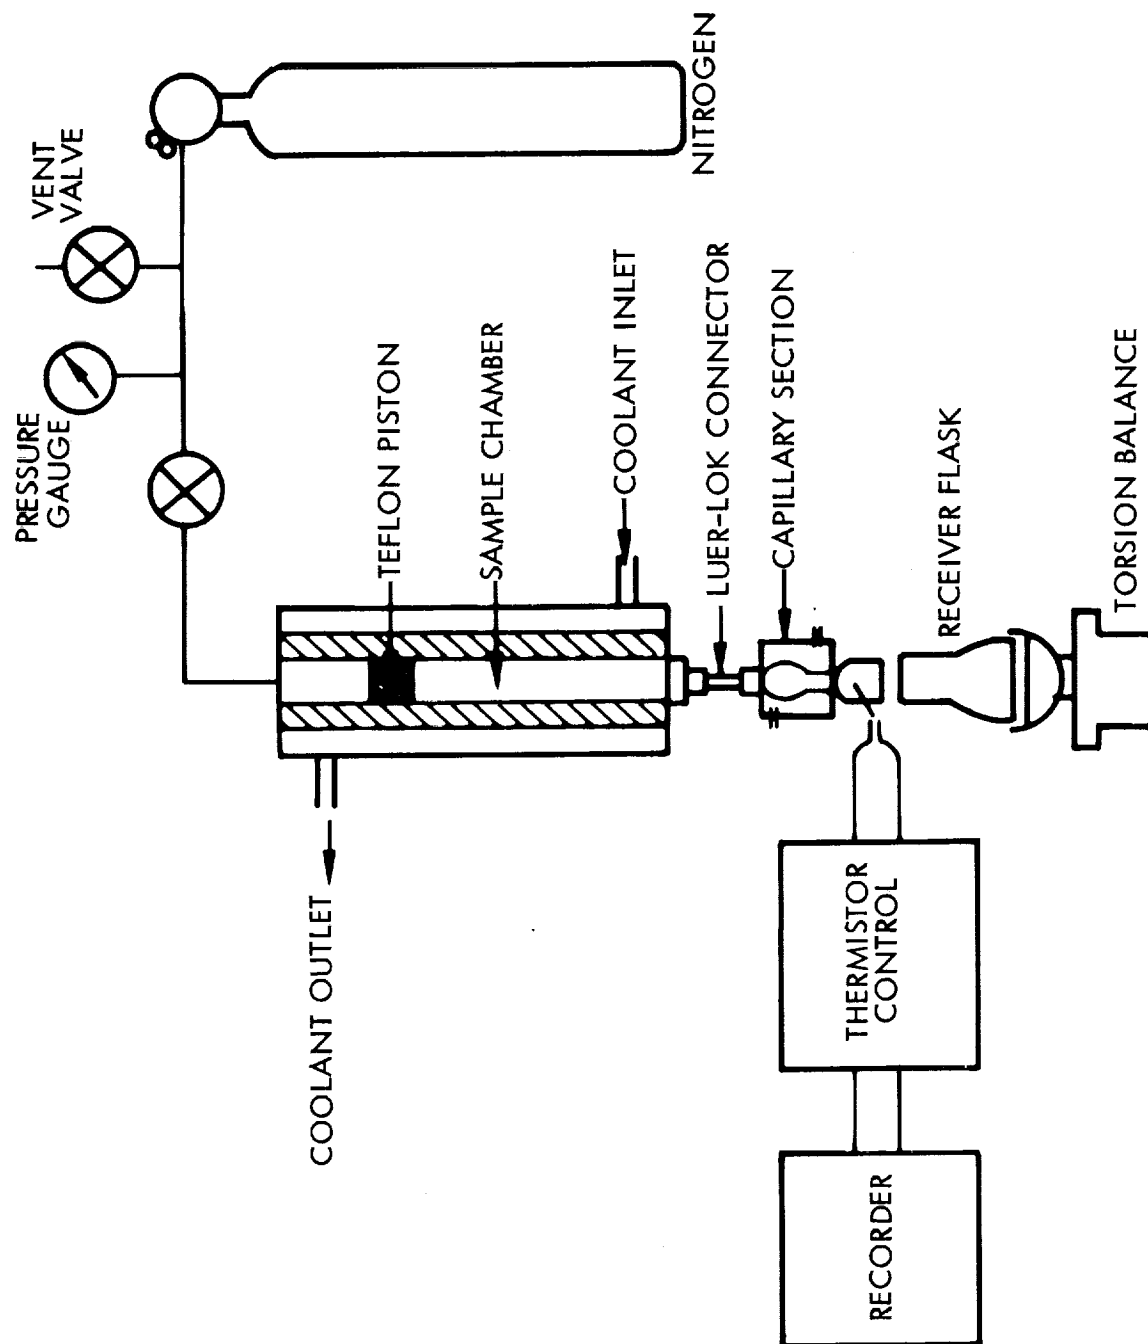
Figure 4-6. Extrusion Rheometer Setup

A schematic diagram of the extrusion rheometer utilized for this study is presented in Figure 4-6. The extrusion rheometer consists of a stainless steel cylinder of 150 cc volume, fitted with a 3/4 inch Teflon piston, a cooling jacket and the supplementary capillary section. A schematic diagram of the capillary section is presented in Figure 4-7. The capillary section consists of an 0.8 inch long glass capillary of 0.005 inch ID, a thermal conditioning chamber and cooling jacket and a thermistor (200Ω at 75°F) for temperature measurement. The thermistor output was recorded on a Sargent Model SR-5 strip chart recorder, while thermistor current was supplied utilizing a Carle Micro Detector Control. Control of the flowing liquid temperature was obtained utilizing a cold water bath circulated through both the cooling jacket of the barrel and the capillary. Hydrazine flow rate was measured by monitoring the weight of hydrazine effluent on a Torbal Torsion Balance as a function of time.

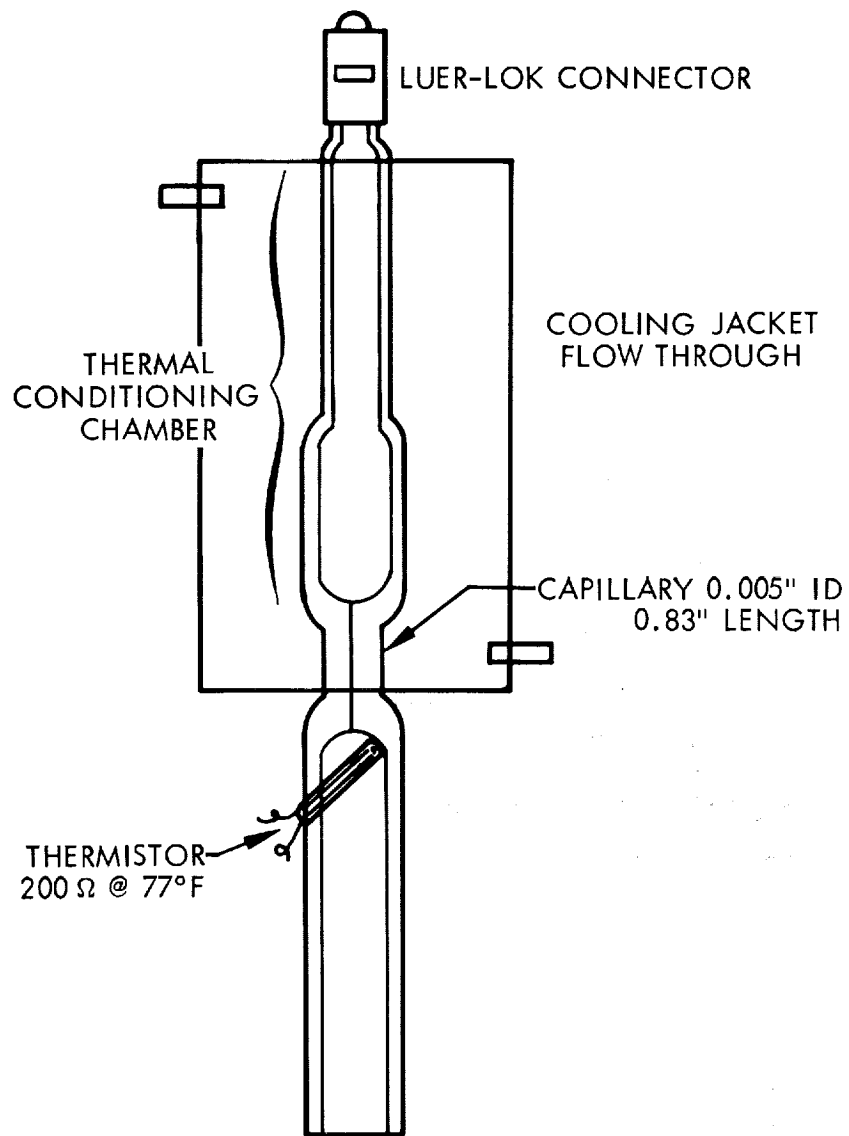
Figure 4-7. Capillary Test Section

Modifications to the previously used rheometer included substitution of the capillary section for the 0.8-inch long capillary needle (0.010-inch I.D.). The capillary section contains an auxiliary cooling jacket to increase the cooling system efficiency. The capillary section also incorporated a thermistor for measurement of flowing liquid temperature which replaced the thermocouple previously used. In addition, the flow rate measurement by weight replaced the previous volumetric measurement. The density of N_2H_4 over the temperature range of 25°C to 2°C varies less than the accuracy of the weight measurements.
